**DESIGN AND SUPERVISION GJIROKASTRA SYSTEM OF MUSEUMS -
MUNICIPALITY OF GJIROKASTRA**

Project ID Number: P15562 / REF No: AL-ADF-15556-CS-CQS

TASK 4: System of Museums (SoM) Detailed Project Design | APRIL 2020

ENVIRONMENTAL AND SOCIAL IMPACT ASSESSMENT

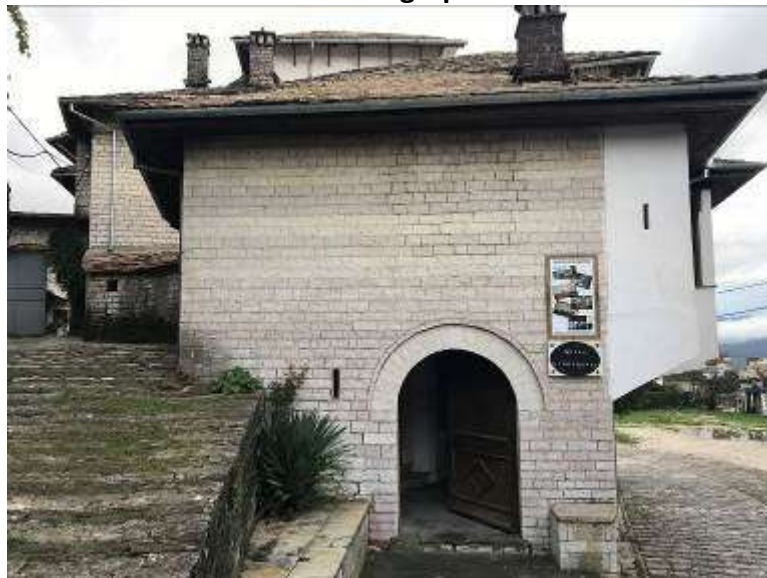
View of the Ethnographic Museum

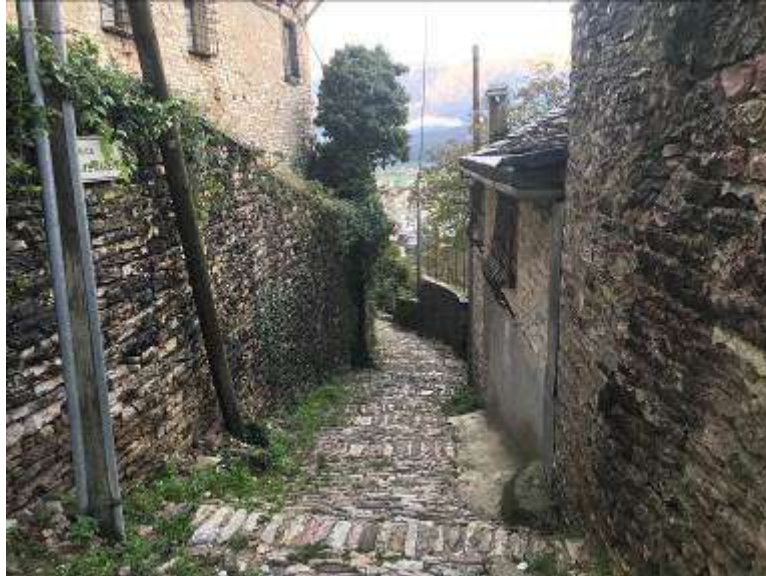
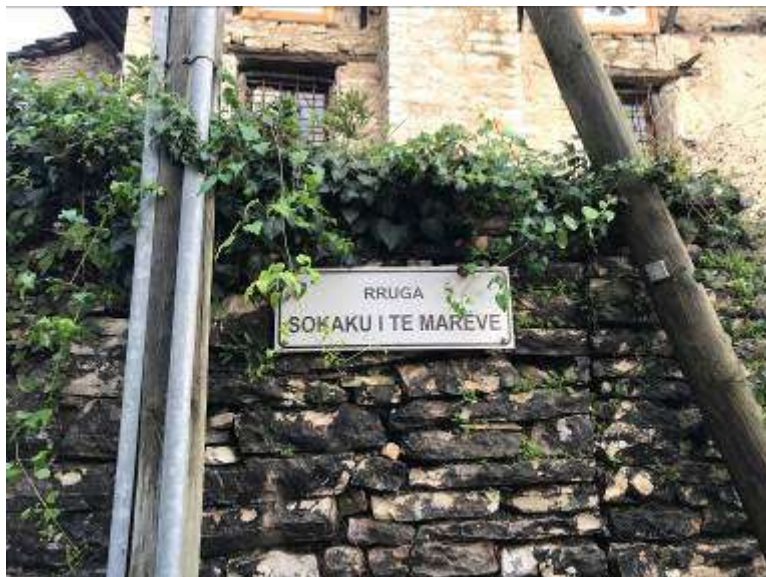
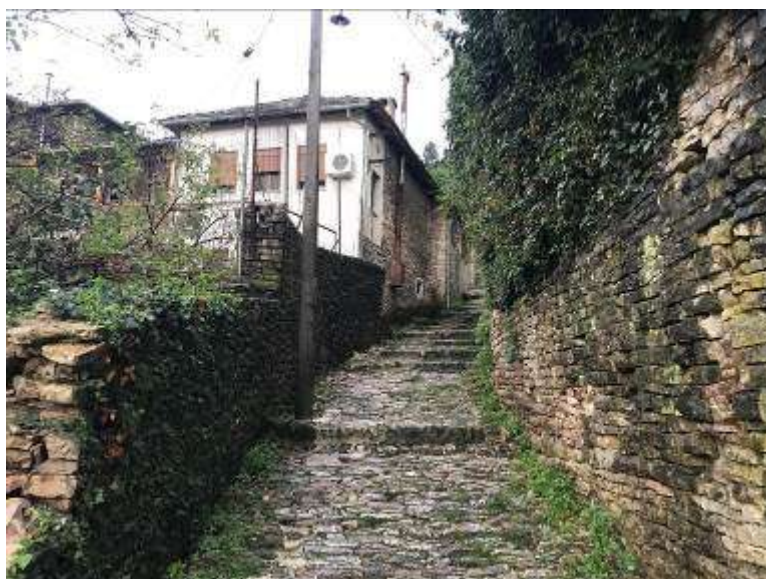
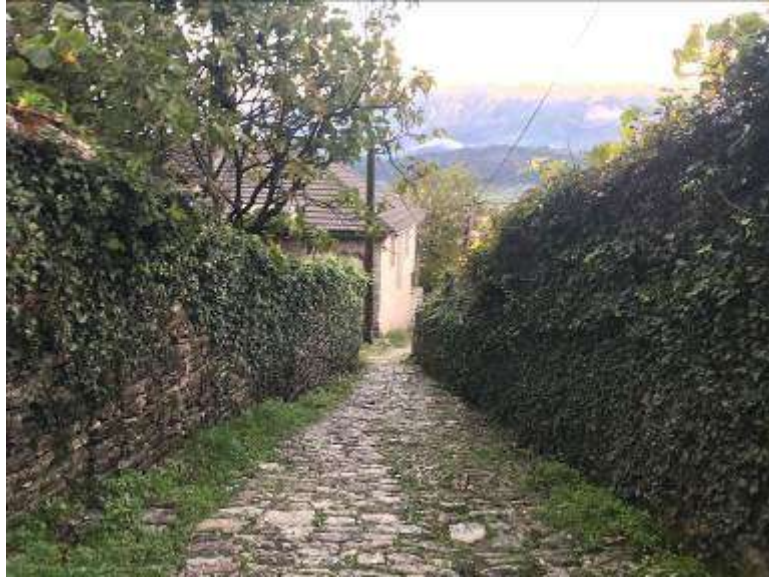
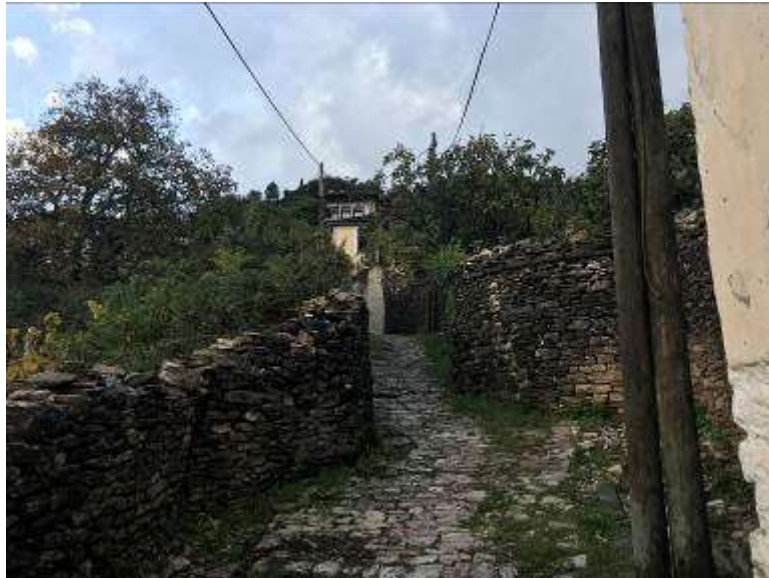
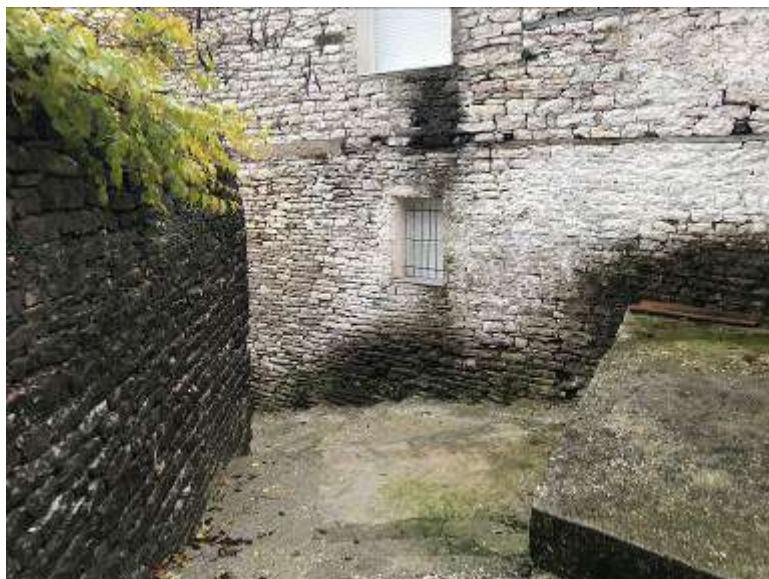
View of different passages from the street “Sokaku I të Marëve”.

A detailed study of the current state of "Alleyu i të marrëve" has been undertaken, assessing all the different sections and elements that need conservation intervention. The most voluminous and urgent needs are those in the consolidation of stone walls on both sides of the alley and damage to some cobblestone segments.

- Metal elements such as iron fences mounted on walls
- Metal pipes installed off the walls, used as structures to support plants like vines
- Concrete layer outside the gates that have covered or removed the cobblestone paving
- Historic gate roofs have been replaced with reinforced concrete covers. Only a gate and a roof at the moment are historic though in a degraded state.

- Street lighting was done before 1990, during the communist period, through reinforced concrete pillars, with highly degraded lamps where only the lamp could be replaced.
- Water distribution units have been recently installed. They are made of plastic, in contrast to traditional ones.

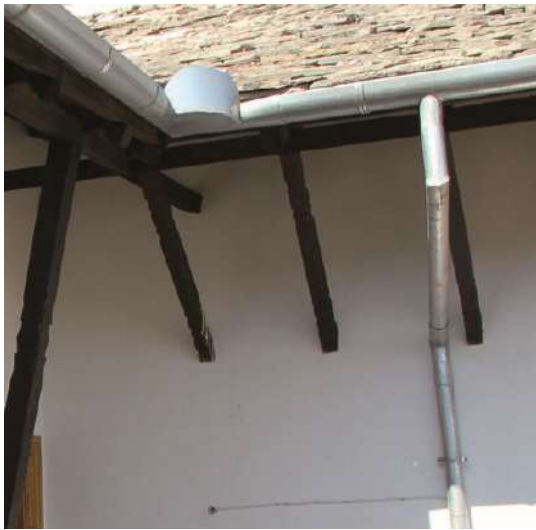
- **Interventions in the gutters**

- **Repairing damaged parts**

Part of the elements of the gutters are detached or damaged. These elements will be replaced or repaired using elements similar to the existing ones.

The new gutter will be the same as the existing ones and will be added to the existing system.

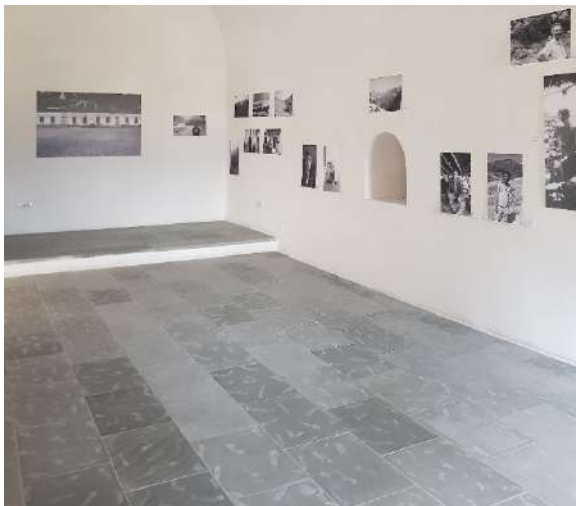
- **Intervention in the floor of the ground floor**

The black stone tiles of the ground floor will change entirely. The existing stone tiles will be removed carefully. Once they are removed the necessary interventions for the placement of the heating system will be done. Finally, new stone tiles will be used for the paving. Traditional materials and techniques will be used to place the new paving.

The changing of the paving will cause the change of level of the ground floor. The precise difference will be evaluated once the works will be finished as it is not possible to do so now. As the underground layers are unknown, it is unclear how much it will be needed to dig

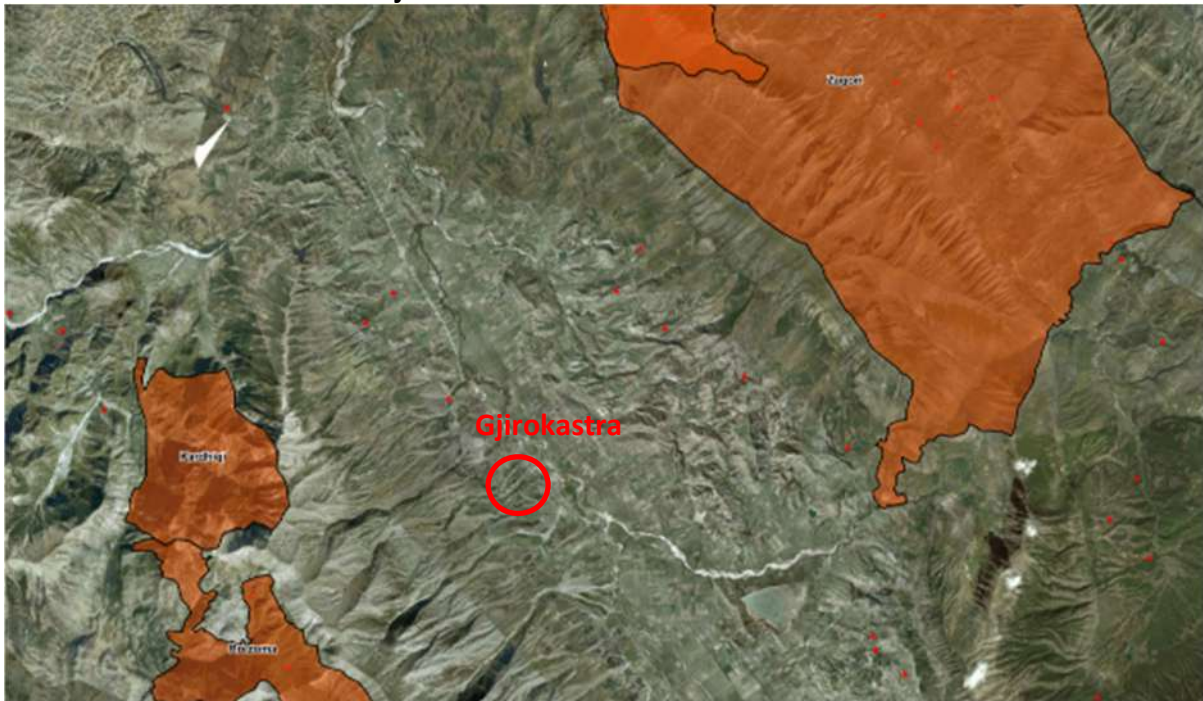
Project distances from Protected Areas

In the area under assessment, no natural monuments have been identified. The closest object has been identified is the "Rapi I Çerçizit", which is about 700 aerial meters away.

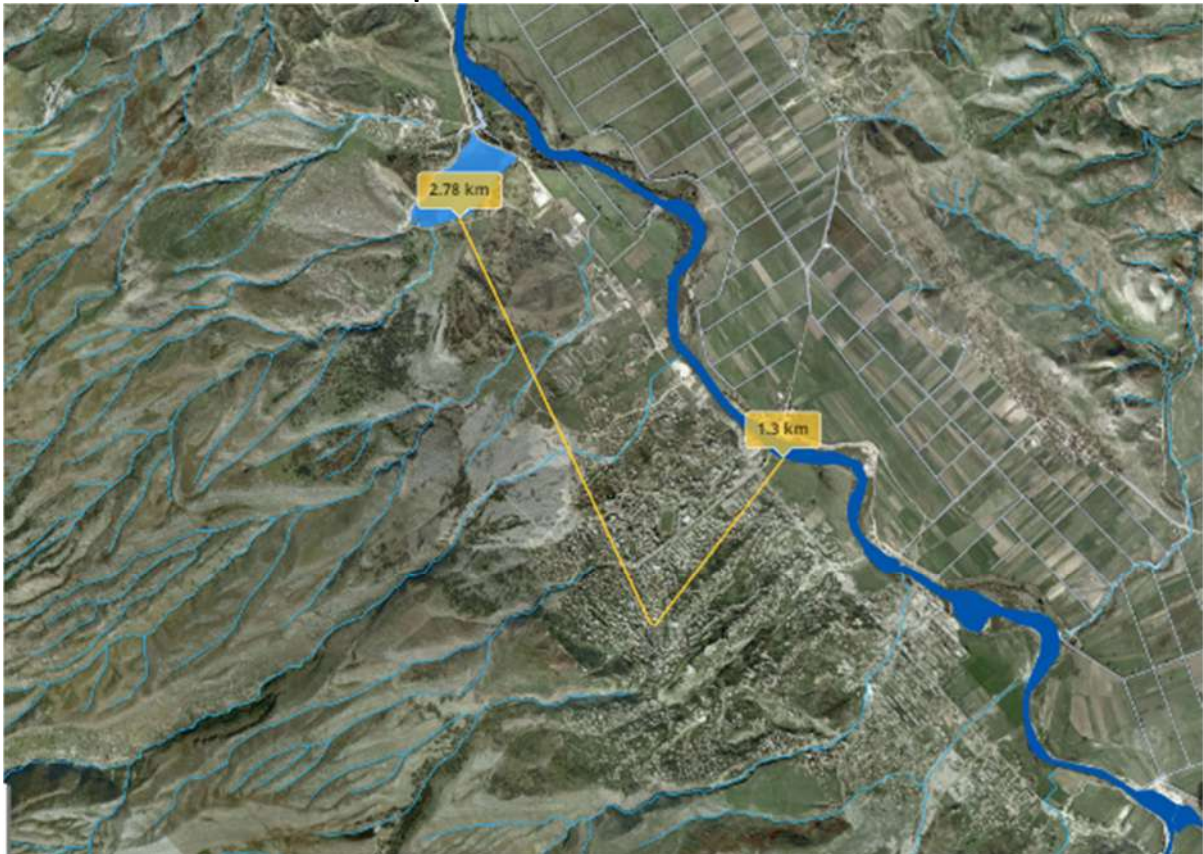
Map of water resources of the area

There are no significant water resources identified in the implementation area of this project. Water sources are located away from the facility. The nearest and most important water source of this area is the Drinos River, about 1.3km northeastward and Viroi, which is about 2.8km northeastward, joining the two along and further along the Kardhiq River about 9km away form the tributary of the Vjose River.
